Manhole Inspection Summary

Manhole # S43A2_029MH

Insp Date: **12/14/07 1:05 PM**

Location Address: **1110 E Patapsco Ave**

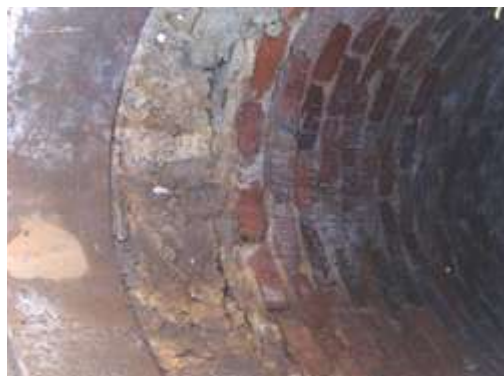
Defect 2

Infiltration: ☐ None ☐ Joint ☐ Cracks ☒ **Mortar** ☐ Roots ☐ Wall

Mortar

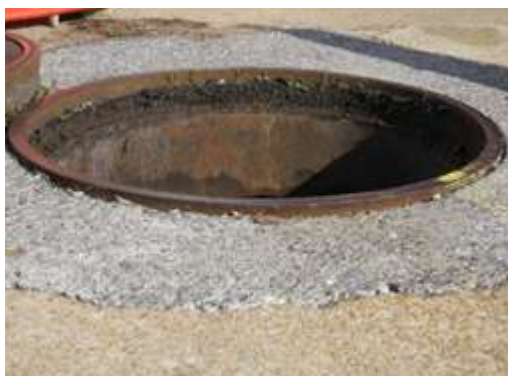
Defect 1

Infiltration: ☐ None ☐ Joint ☐ Cracks ☐ Mortar ☐ Roots ☒ **Wall**

Above grade

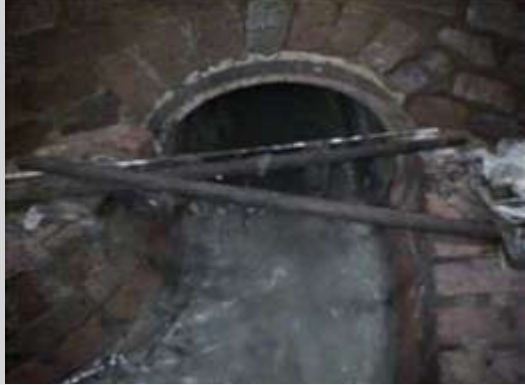
12 O'Clock Outflow

15 in. Circular Gravity Sewer
Pipe Out @ 12 O'Clock

Pipe Height: **18** (in.) Rod and Bar (Angled)
Pipe Material: **Clay** ☐ Pipe Lined
Invert Depth: **15.16** (ft.) Flow Characteristics: **Fast**
Deposits: ☒ None ☐ Mud ☐ Sludge ☐ Debris ☐ Grease
Silt Depth: (in.) Deposits Extent:
Infiltration: **None** Pipe Seal Cond: **Sound**

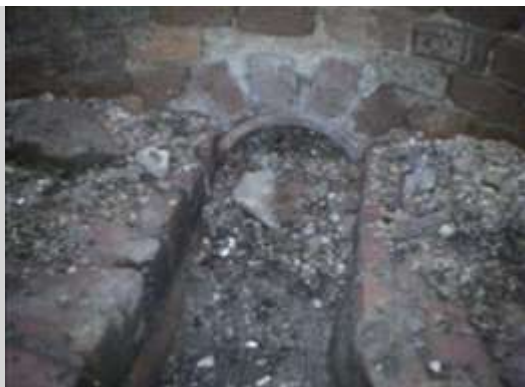
6 O'Clock Inflow

Comments **Measurement for influent pipe @ 6 O'clock unobtainable due to debris.**

6 in. Circular Gravity Sewer
Pipe In @ 6 O'Clock

Pipe Height: **3.6** (in.) Rod and Bar (Angled)
Pipe Material: **Clay** ☐ Pipe Lined
Invert Depth: (ft.) Flow Characteristics: **None**
Deposits: ☐ None ☐ Mud ☐ Sludge ☒ **Debris** ☐ Grease
Silt Depth: **10** (in.) Deposits Extent: **Heavy**
Infiltration: **None** Pipe Seal Cond: **Sound**

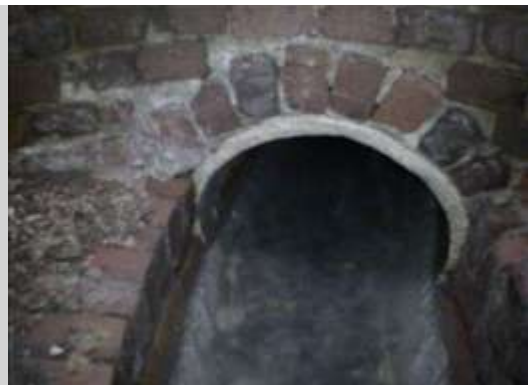
9 O'Clock Inflow

15 in. Circular Gravity Sewer
Pipe In @ 9 O'Clock

Pipe Height: **18** (in.) Rod and Bar (Angled)
